CONTINUING ELIGIBILITY INSPECTION (CEI) REPORT
FOR HURRICANE & SHORE PROTECTION PROJECTS
Honolulu Engineer District
CEPOH-EC-T

1. Project Name: Pago Pago Int'l Airport Shore Protection Project
2. Date of Inspection: March 18, 2005
3. Inspection Personnel:

Project Rating: **"U, Unsatisfactory"**
Project Condition Code: **"U, Unacceptable"**
Project Status: **"Inactive"**

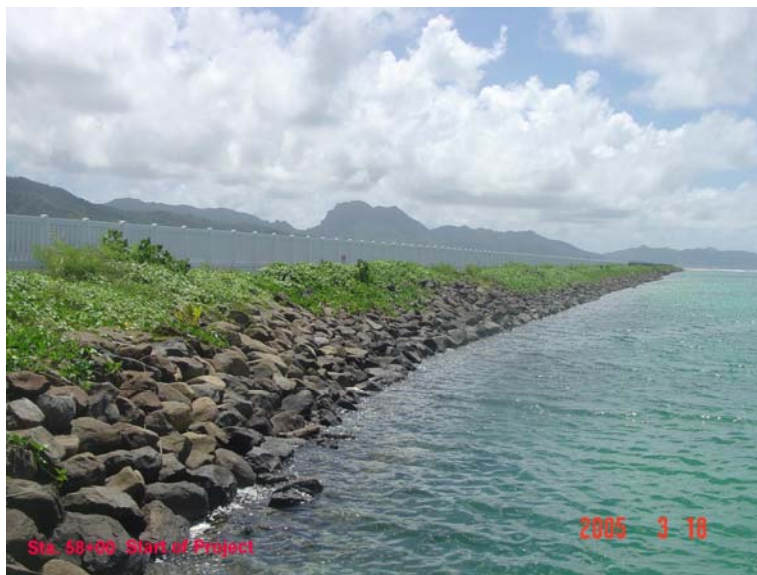
- a. Overview of the Project w/new fences installed.

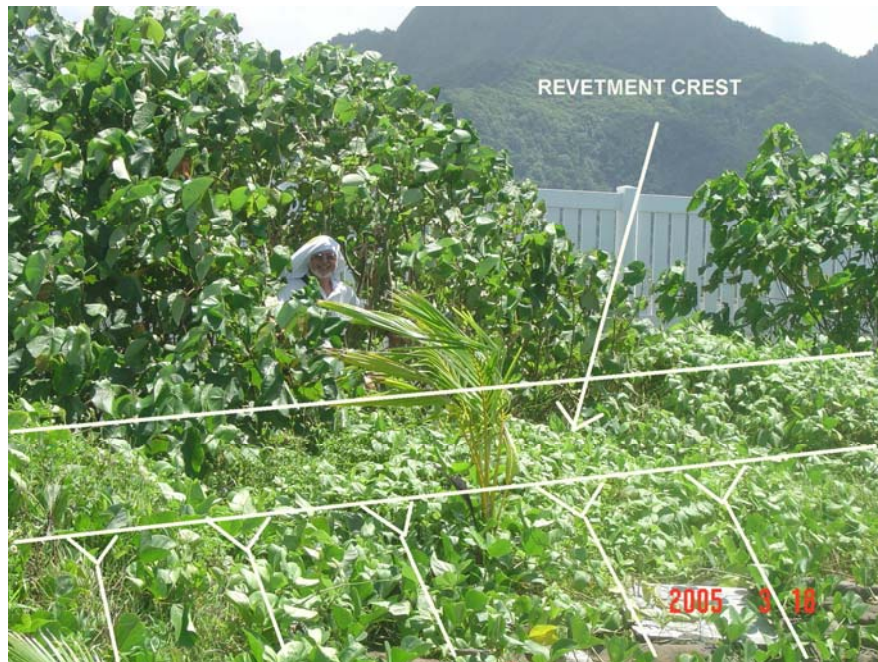
b. Sta. 58+10, interior sideslope , crest and a portion of the oceanside sideslope of the revetment is overgrown with vegetation, unable to inspect.

a. The focus of the maintenance required should be directed at vegetation control. Herbicides and removal of woody vegetation is recommended in lieu of cutting.

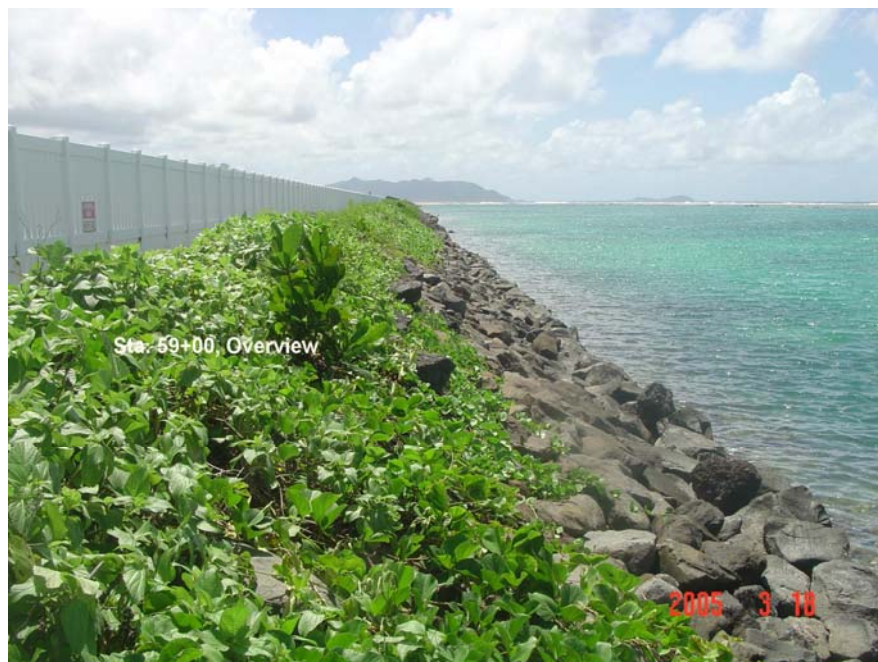
c. Sta. 59+00, remove vegetation.

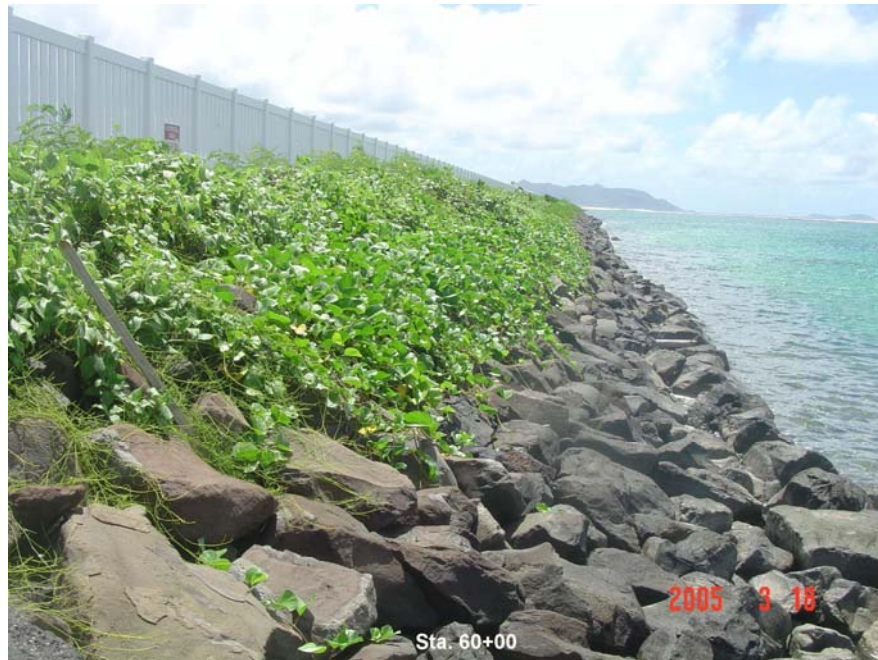
d. Sta. 60+00, remove vegetation.

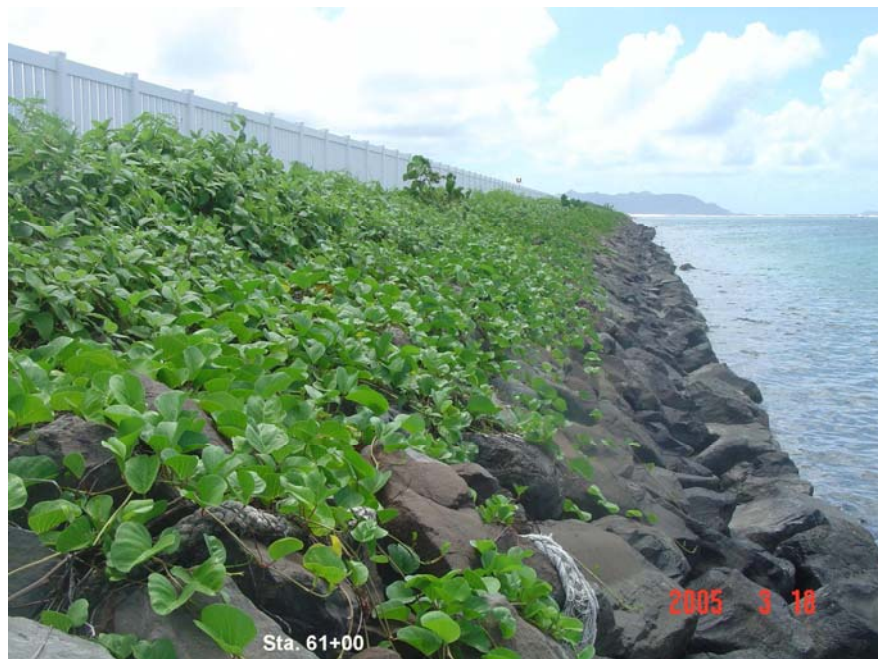
e. Sta. 61+00 remove vegetation.

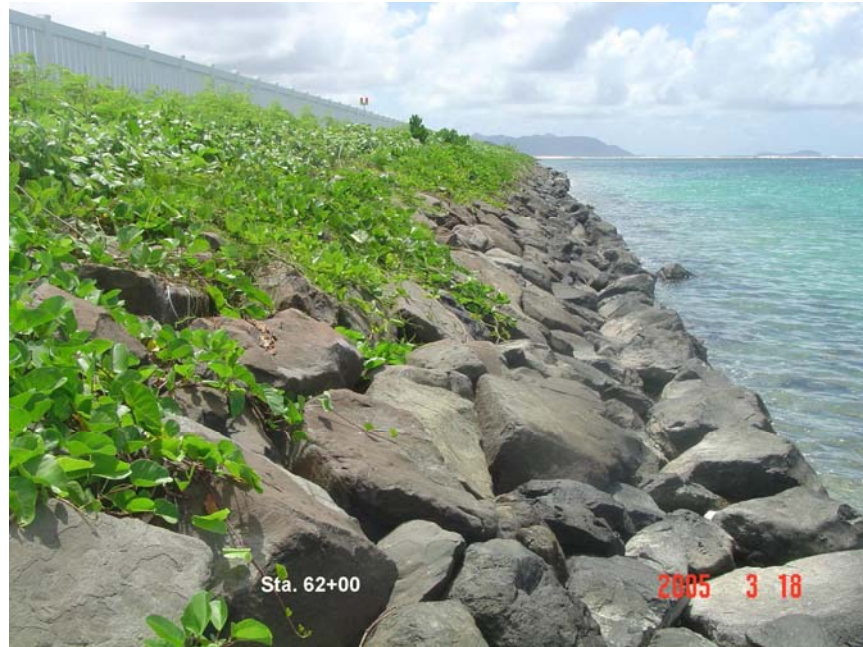
f. Sta. 62+00 remove vegetation.

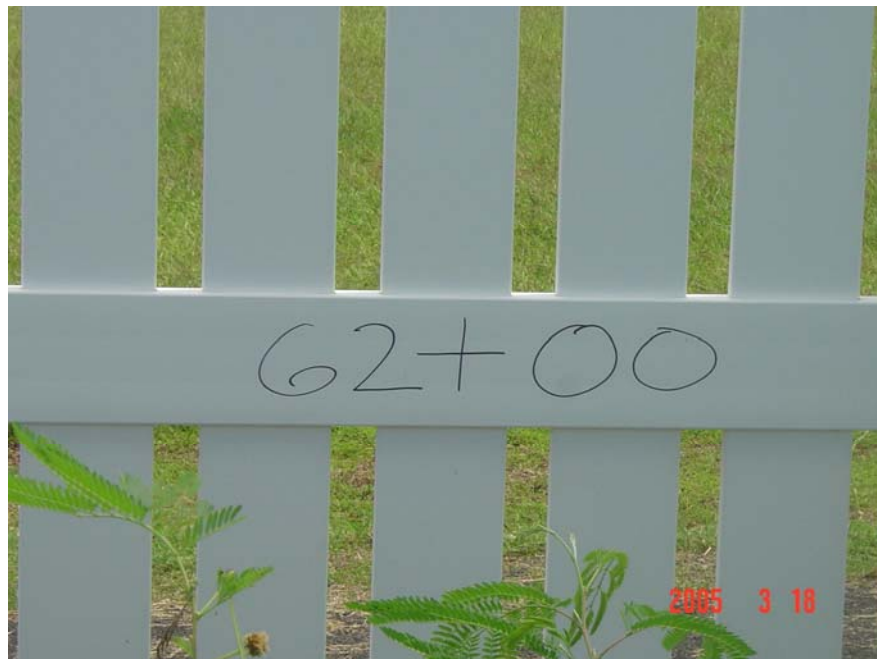
g. Sta. 62+00, revetment station numbers marked on PVC fence.

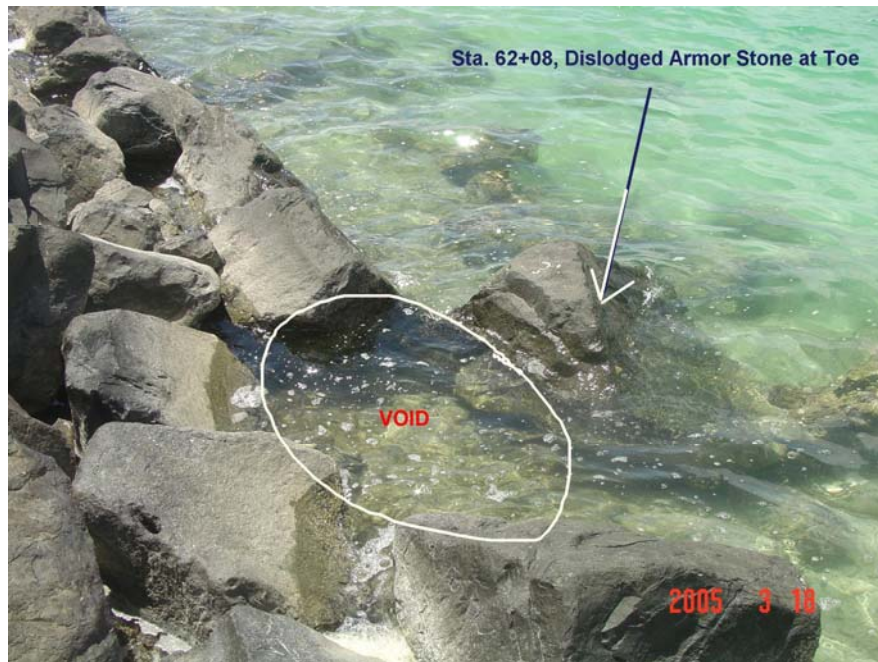
- h. Sta. 62+08, reset dislodged armor stone in adjacent void.

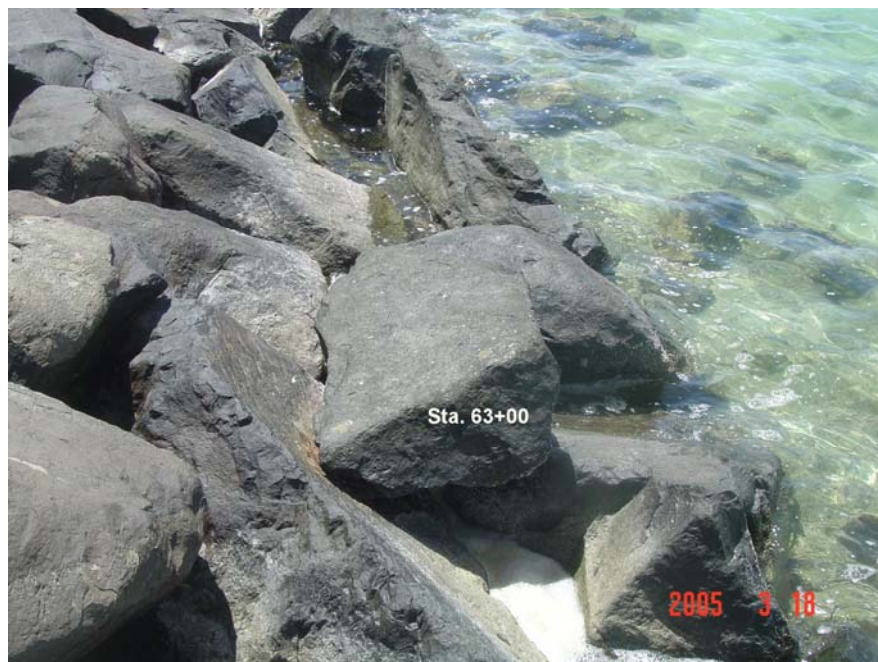
- i. Sta. 63+00, monitor armor stone movement.

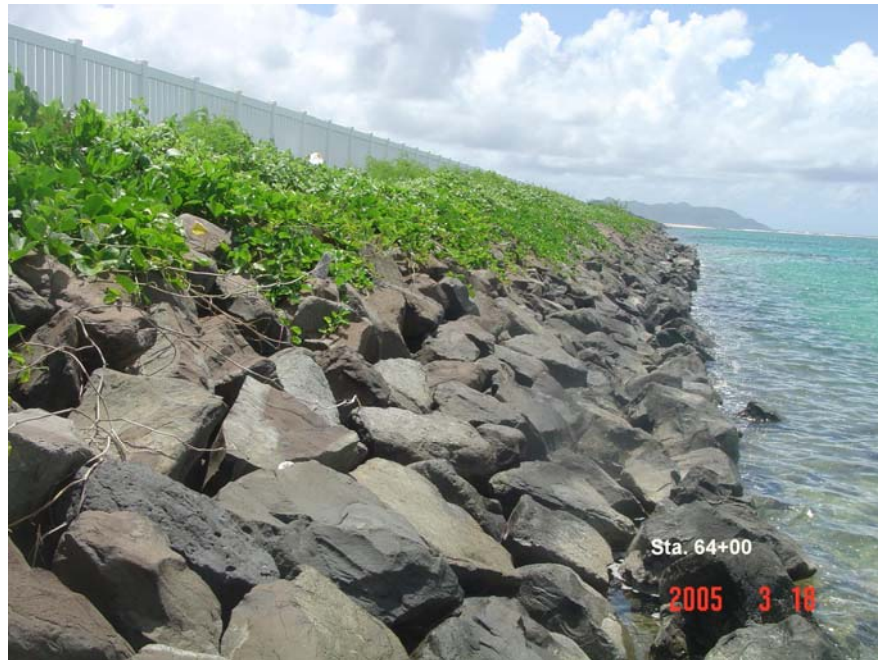
j. Sta. 64+00, remove vegetation.

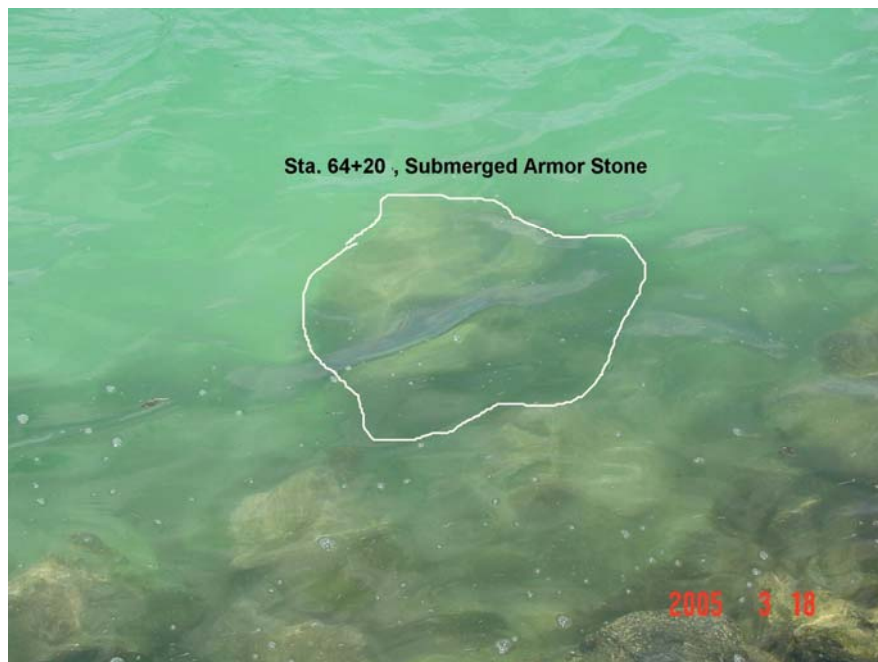
k. Sta. 64+20, monitor armor stone movement.

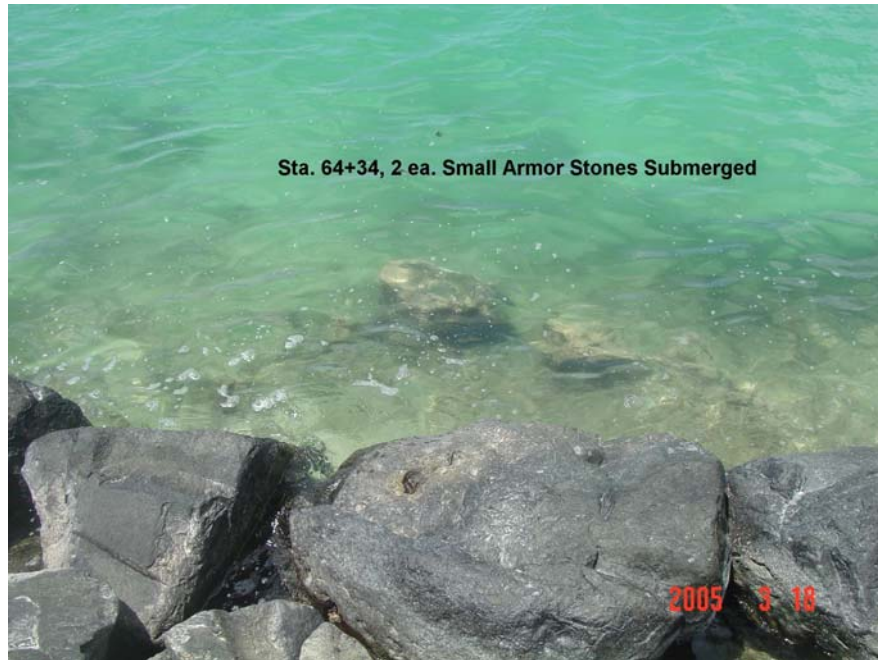
- l. Sta. 64+34, monitor armor stone movement.

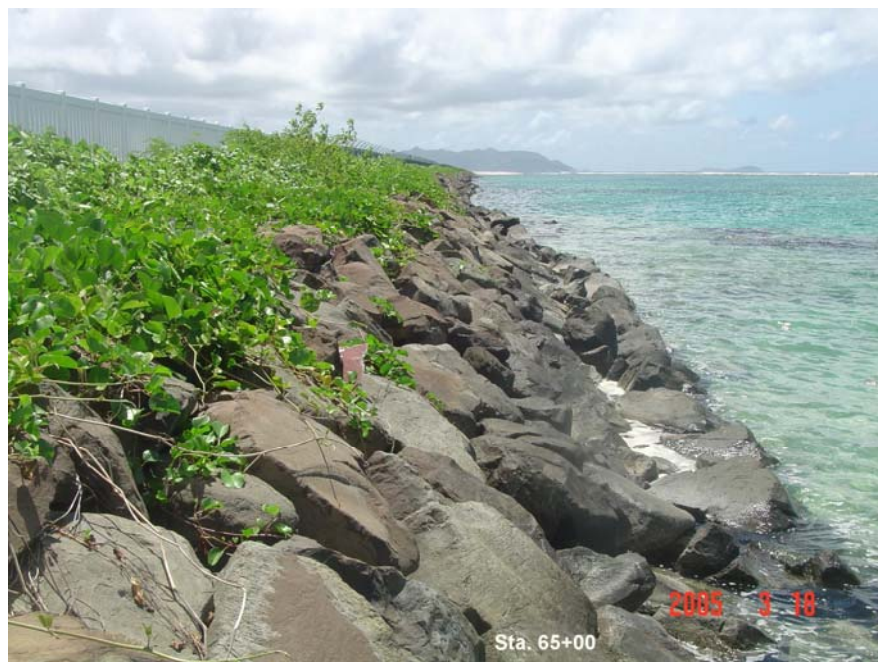
- m. Sta. 65+00, remove vegetation.

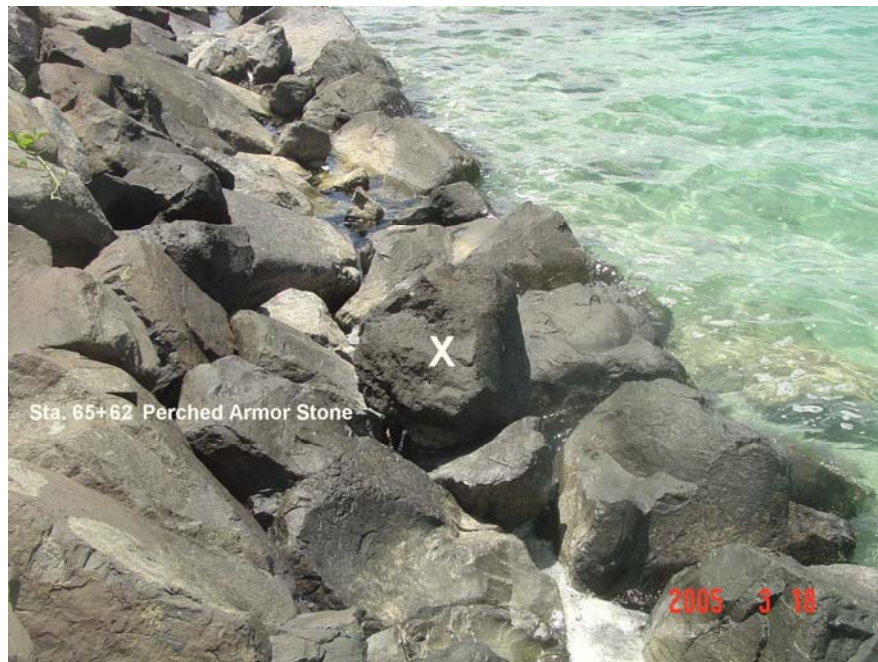
n. Sta. 65+62, monitor perched armor stone.

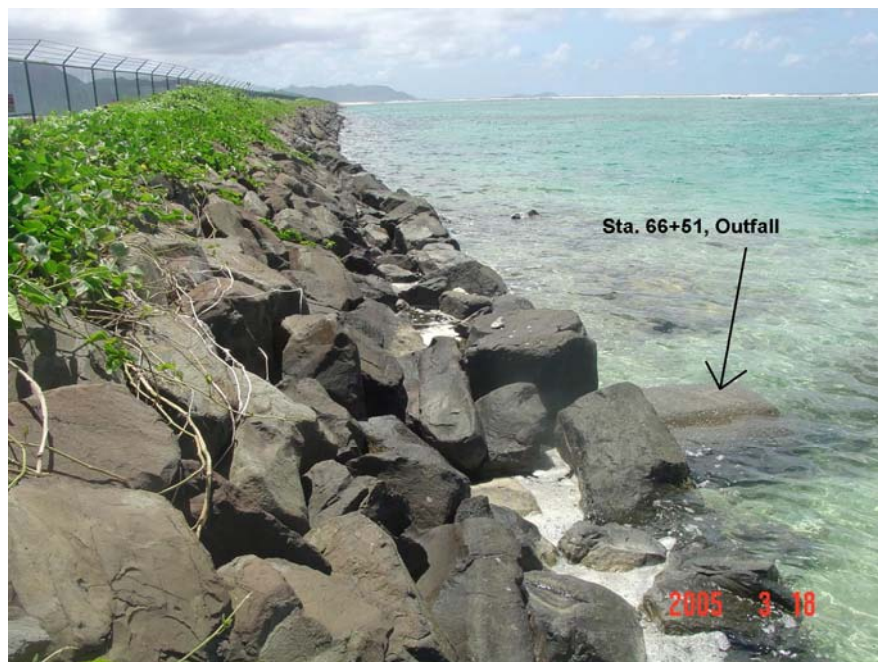
o. Sta. 66+51, reference point existing outfall.

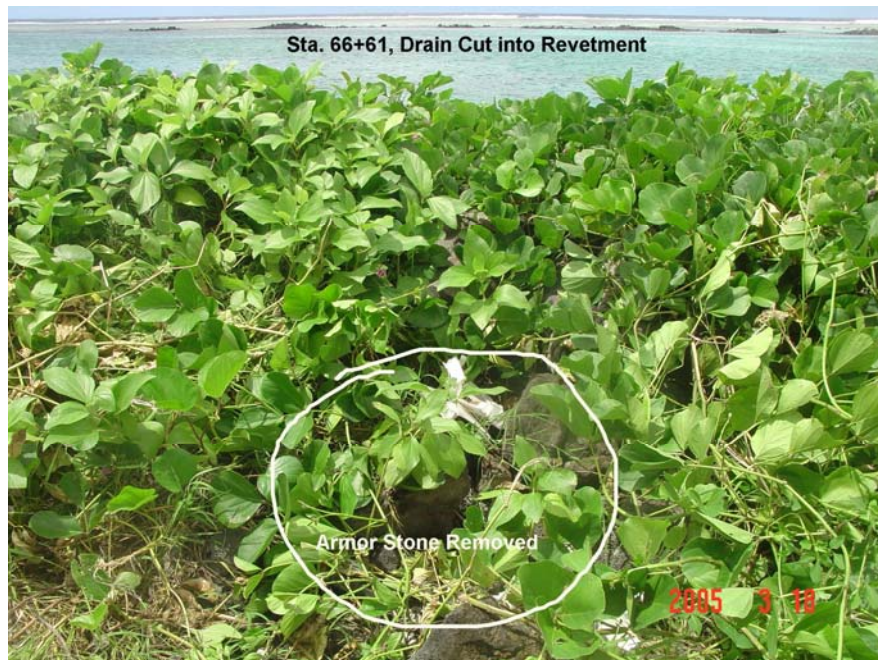
p. Sta. 66+61, armor stone removed and drainline installed $\frac{1}{2}$ thru the center of the crest, remove drainline and reset armor stones.

b. Ports Administration needs to submit proposed correction (details) for the unauthorized drainlines installed partially thru the revetment structure without approval.

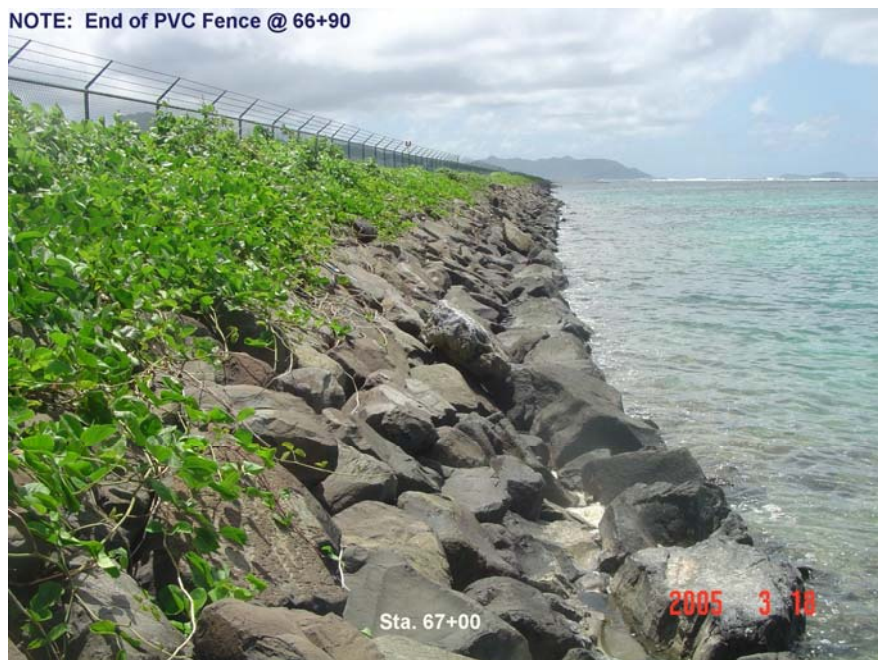
q. Sta. 67+00, remove vegetation.

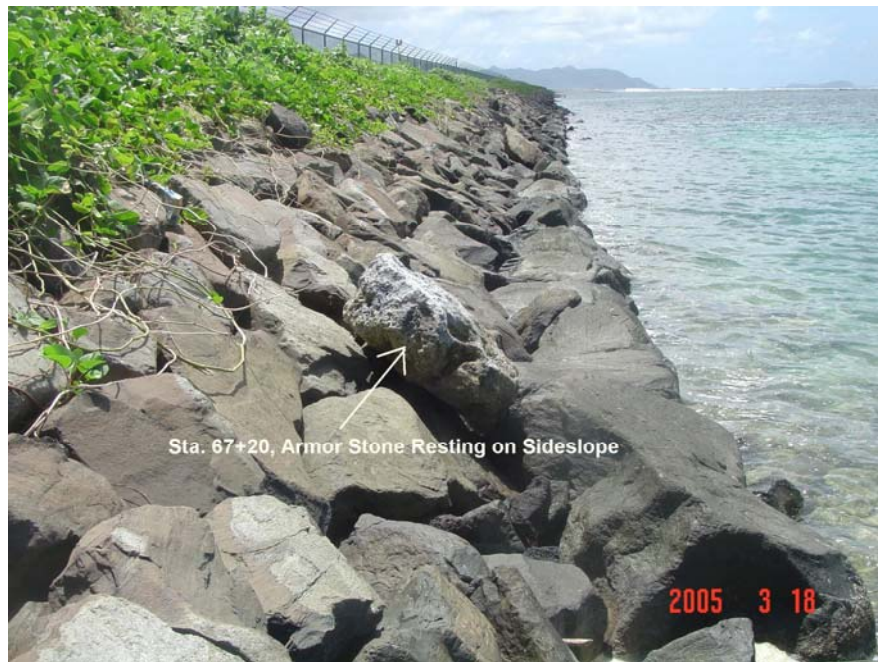
r. Sta. 67+20, monitor perched armor stone, remove vegetation.

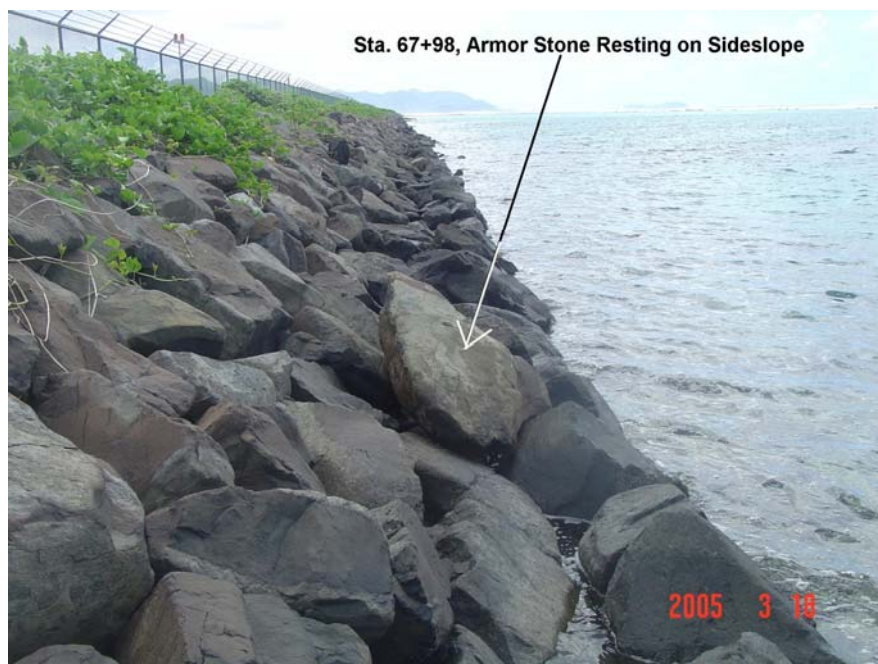
s. Sta. 67+98, monitor armor stone resting on sideslope.

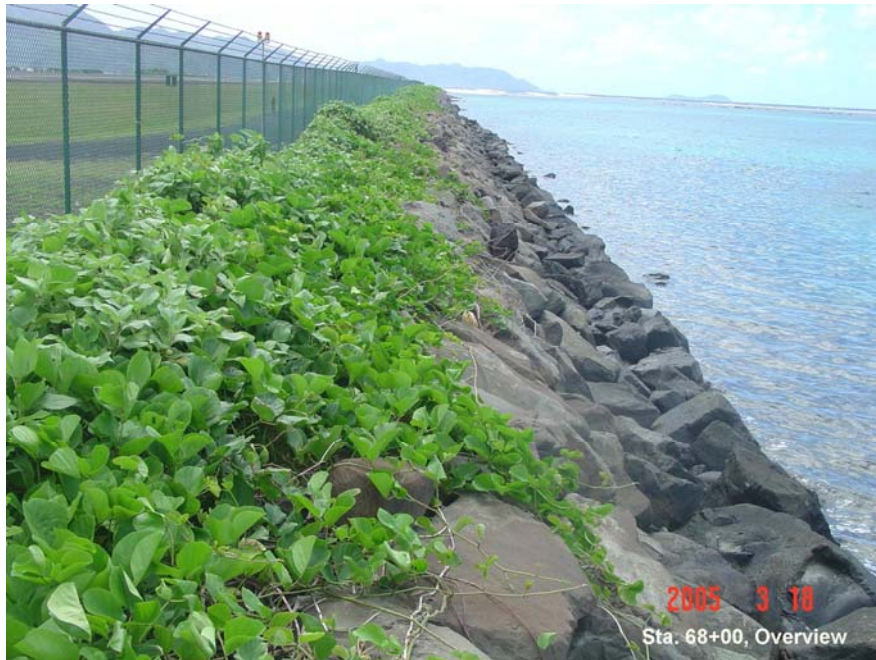
t. Sta. 68+00, remove vegetation.

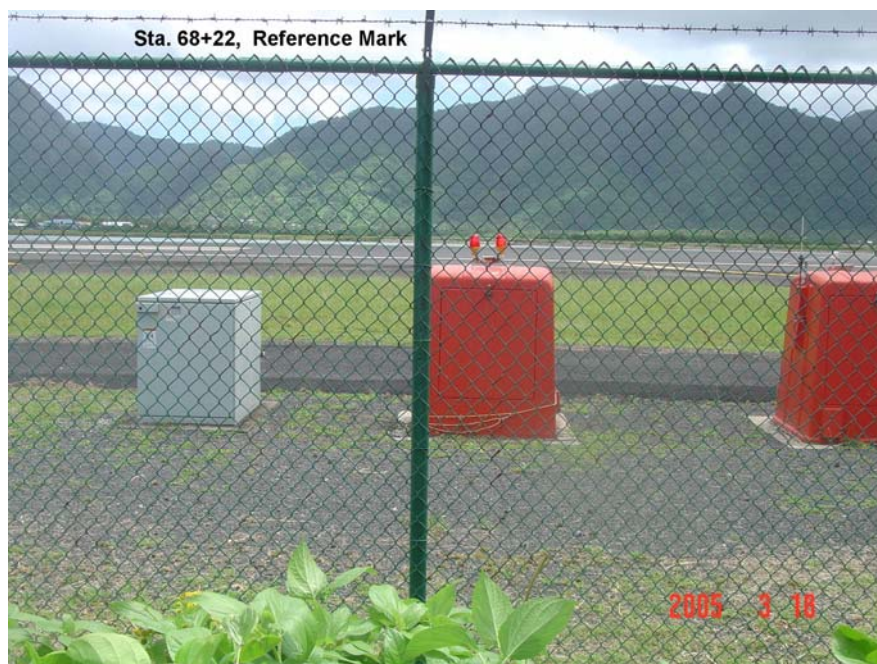
u. Sta. 68+22, station reference photo.

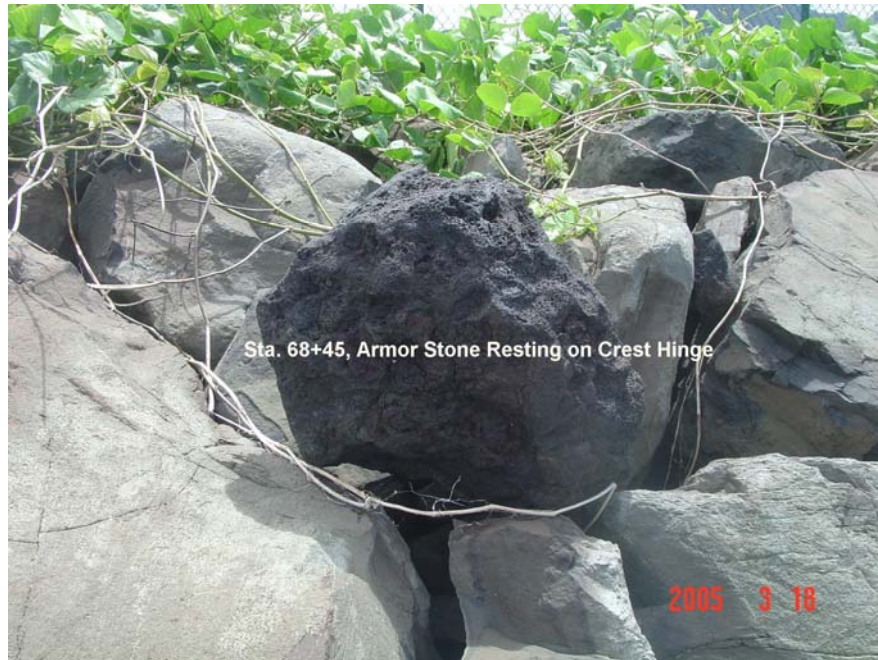
- v. Sta. 68+45, monitor armor stone resting at hinge.

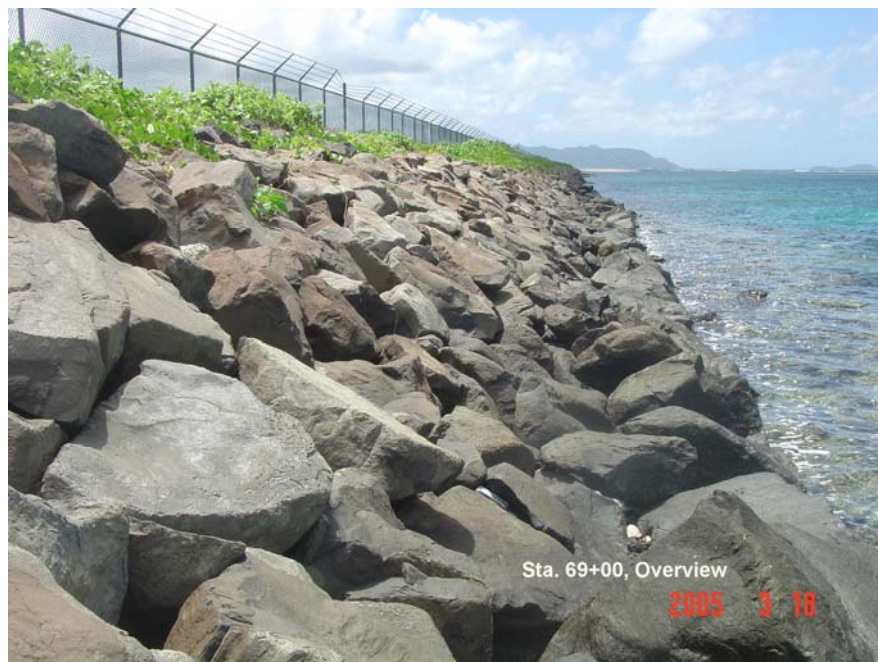
- w. Sta. 69+00, overview.

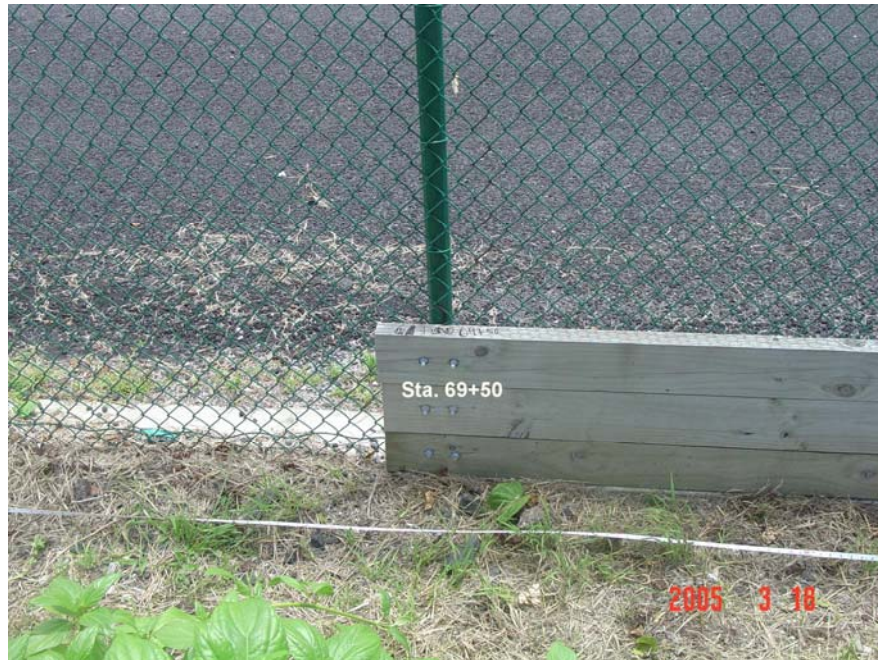
x. Sta. 69+50, station reference point.

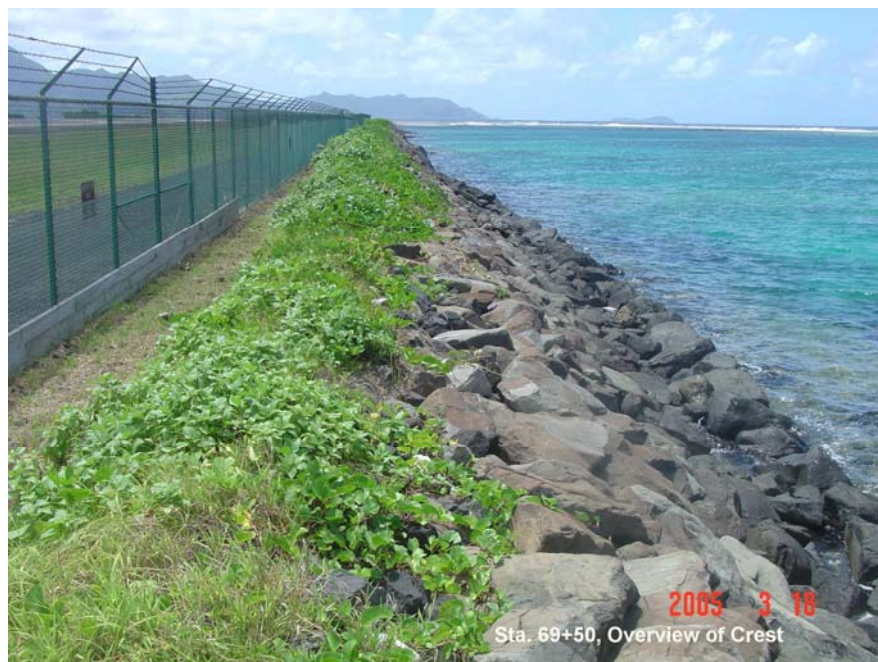
y. Sta. 69+50, overview remove vegetation from crest.

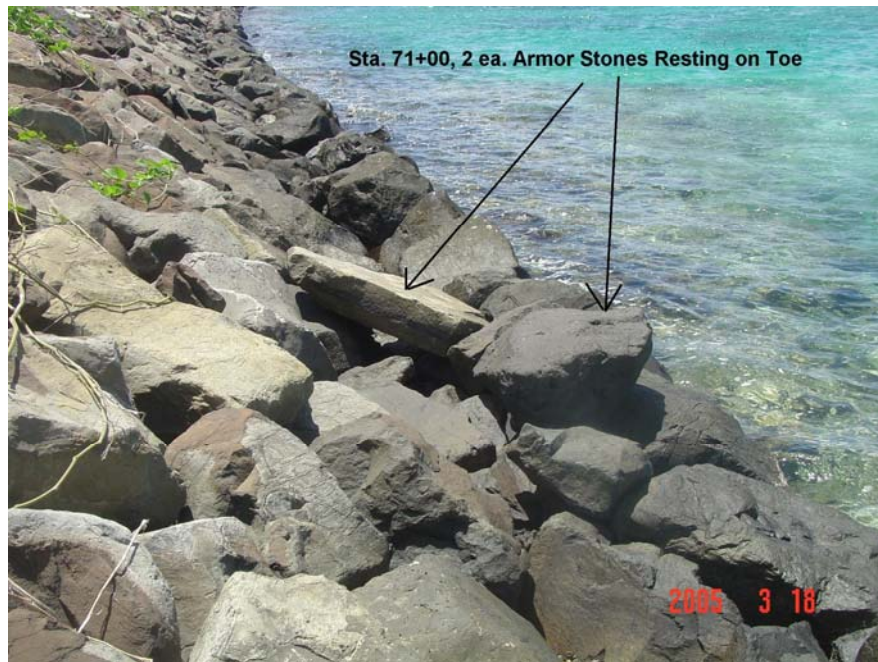
z. Sta. 71+00, monitor 2 ea. Armor stones resting adjacent toe.

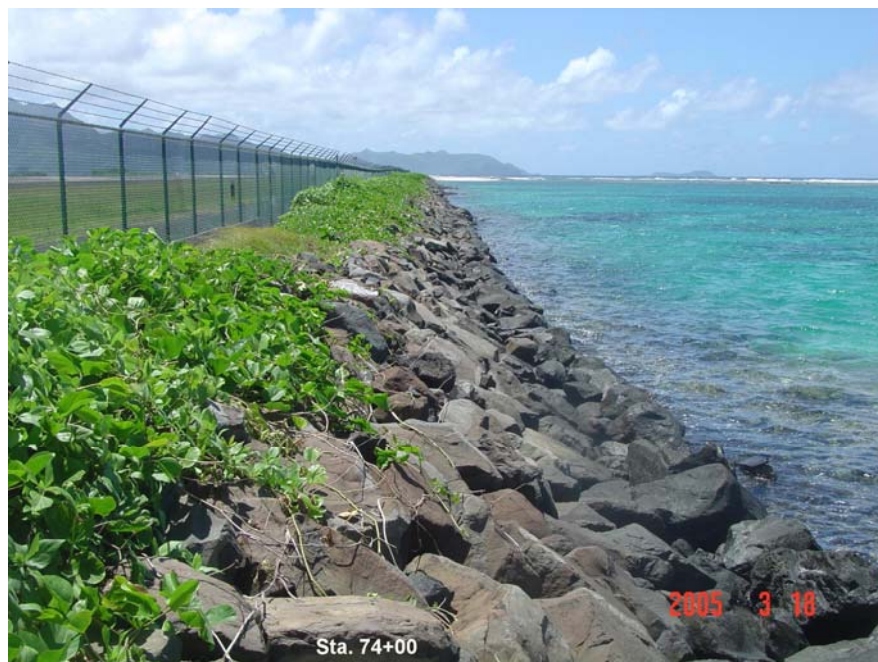
aa. Sta. 74+00, overview, remove vegetation.

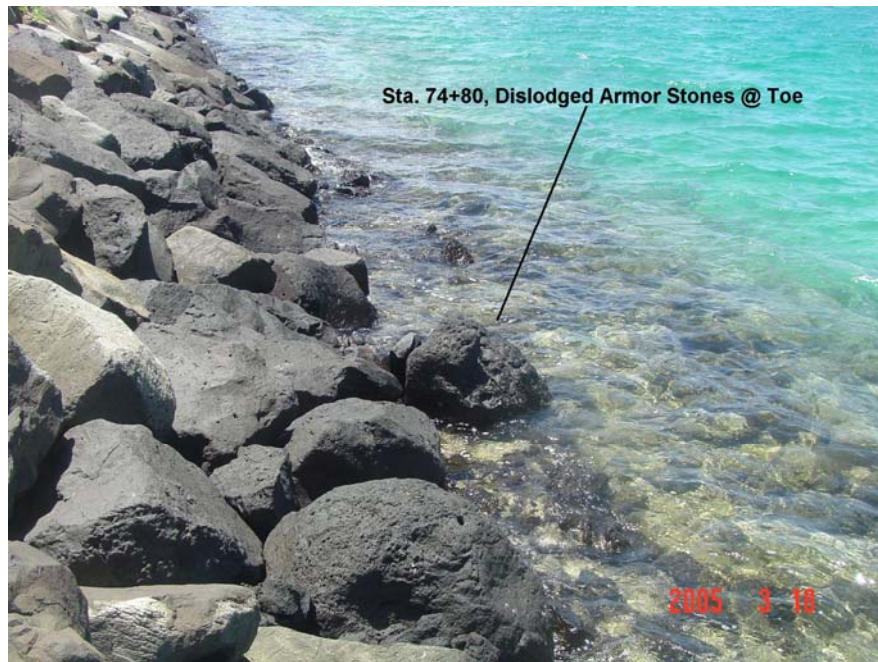
bb. Sta. 74+80, monitor dislodged armor stones at toe.

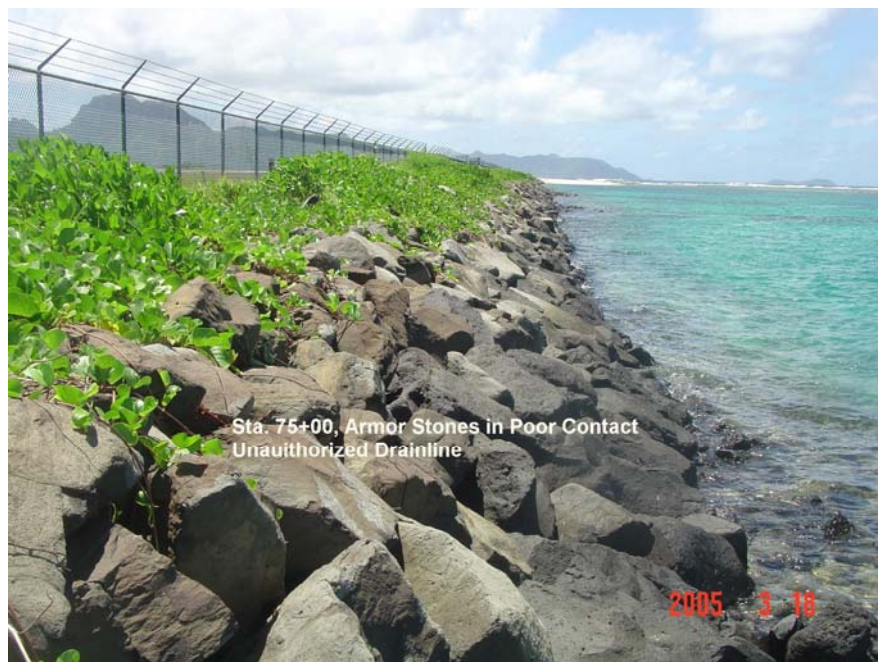
cc. Sta. 75+00, armor stones with poor contact adjacent drainline.

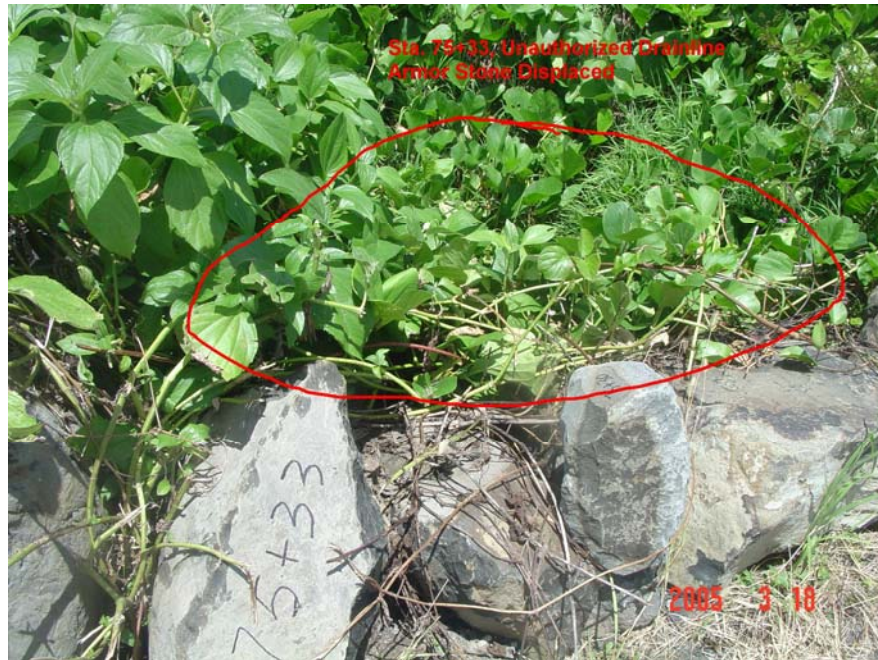
dd. Sta. 75+33, remove unauthorized drainline and reset displaced armor stones.

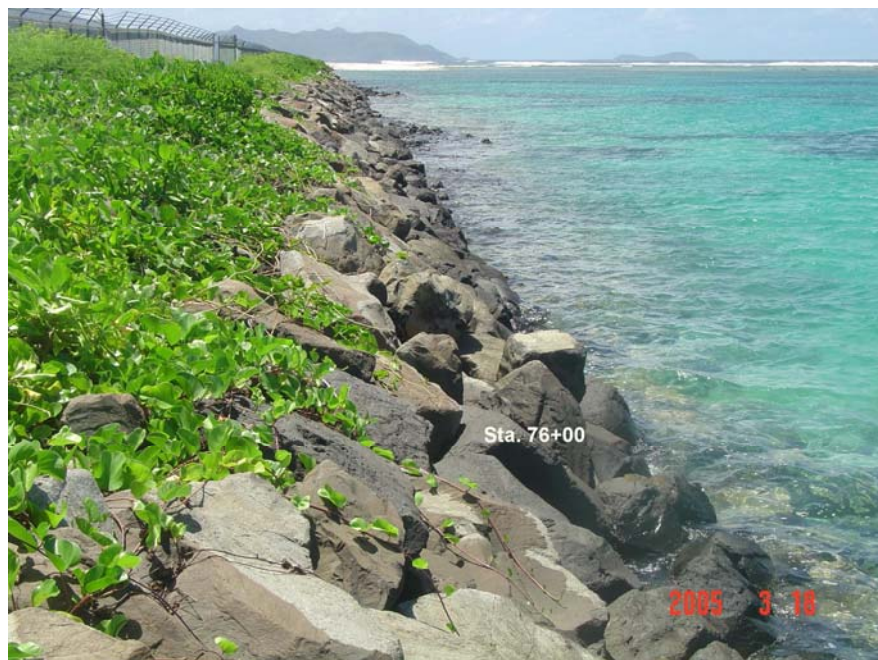
ee. Sta. 76+00, remove vegetation.

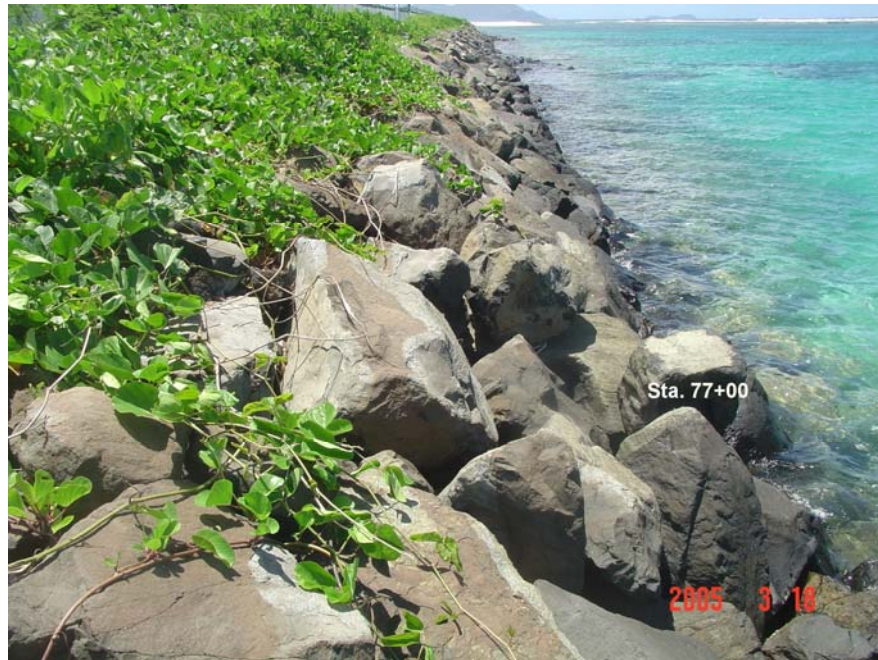
ff. Sta. 77+00, remove vegetation.

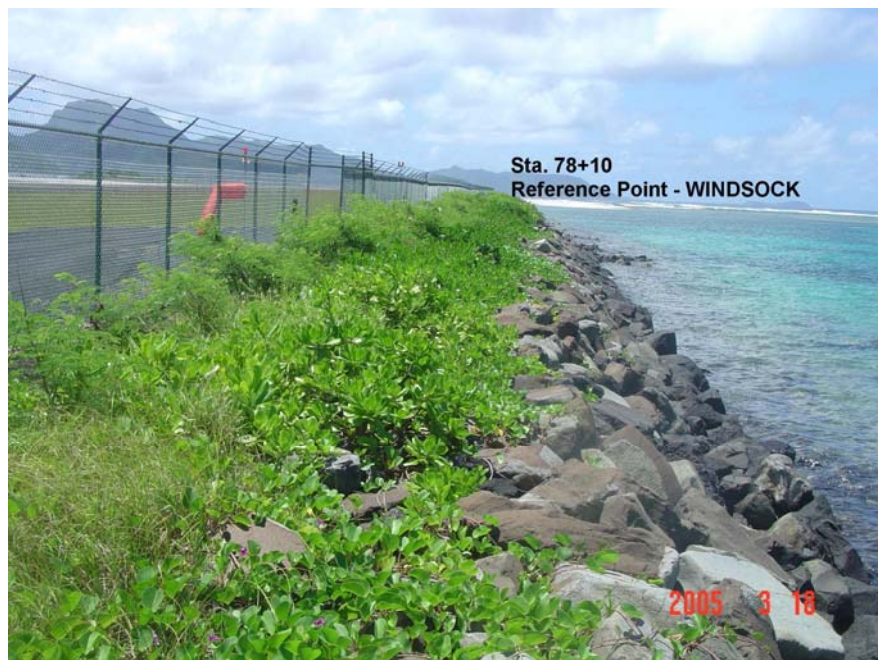
gg. Sta. 78+10, windsock (station reference point).

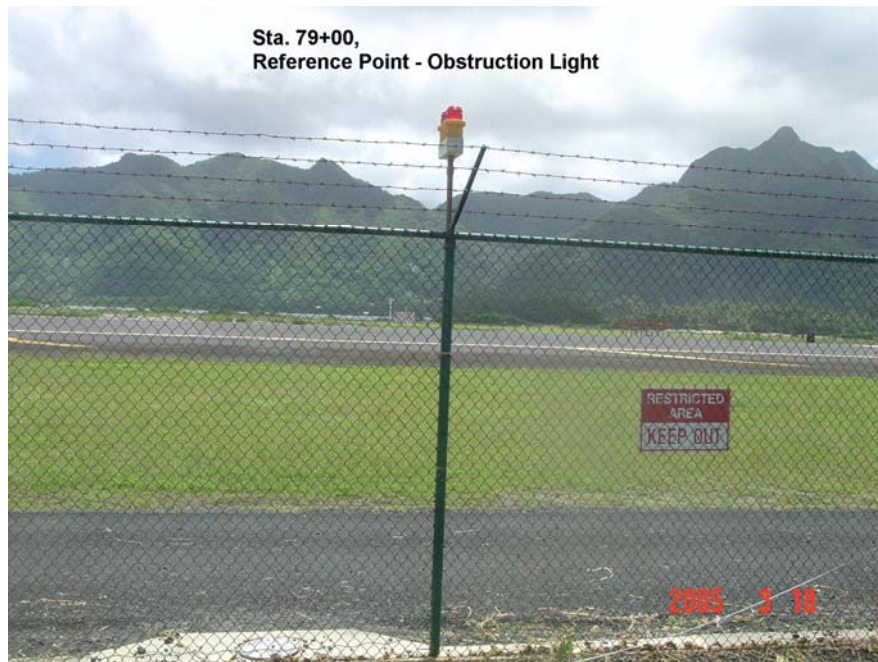
hh. Sta. 79+00, Obstruction Lights (station reference point).

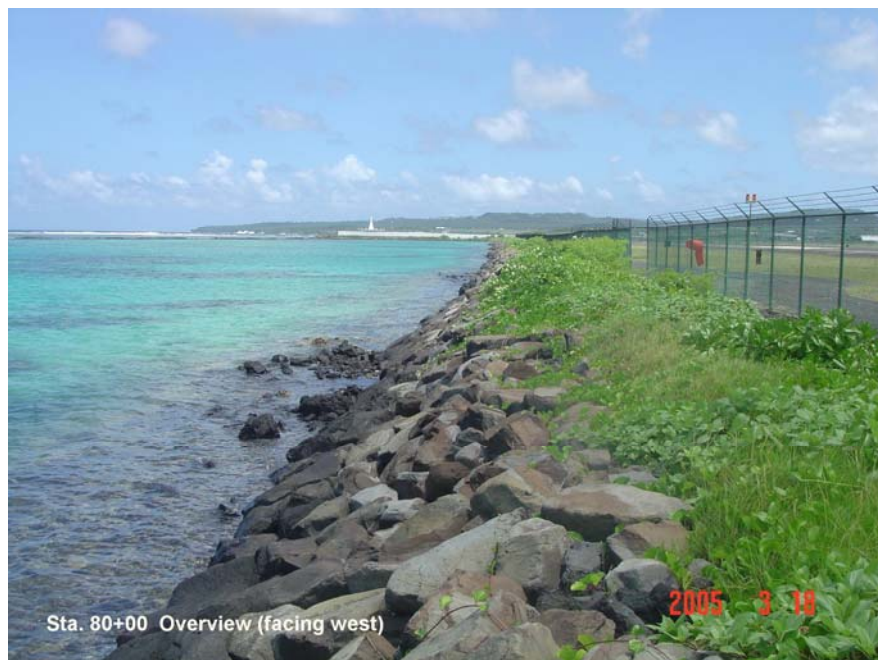
ii. Sta. 80+00, overview of revetment facing west (Sta. 0+00).

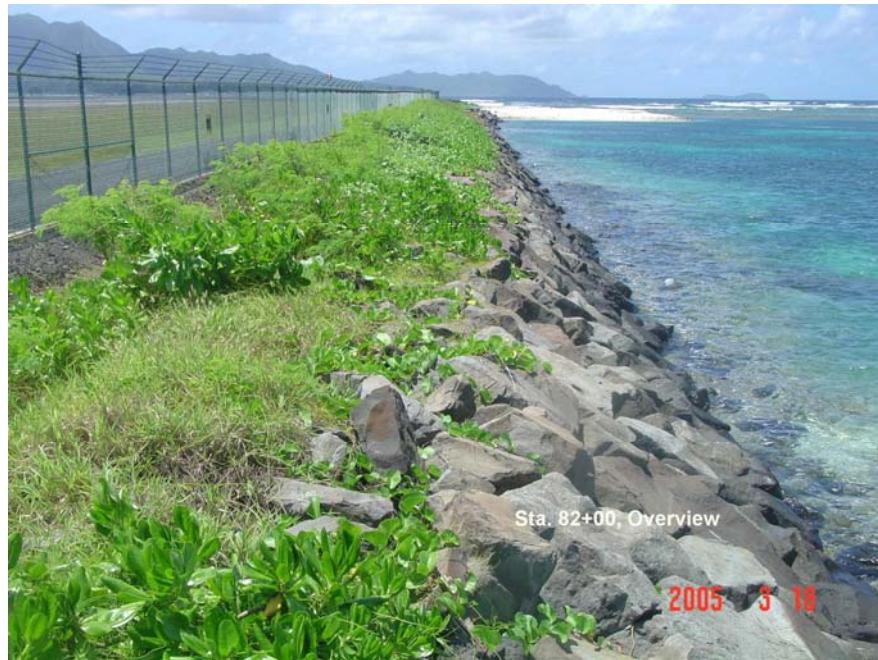
jj. Sta. 82+00, remove vegetation.

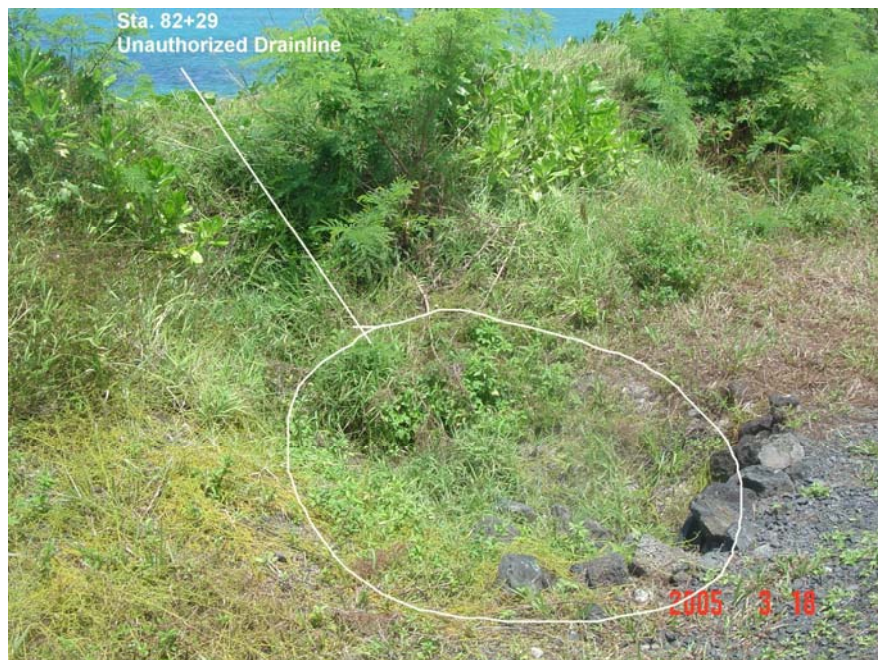
kk. Sta. 82+29, Unauthorized drain adjacent toe of the structure, repair swale cut into structure.

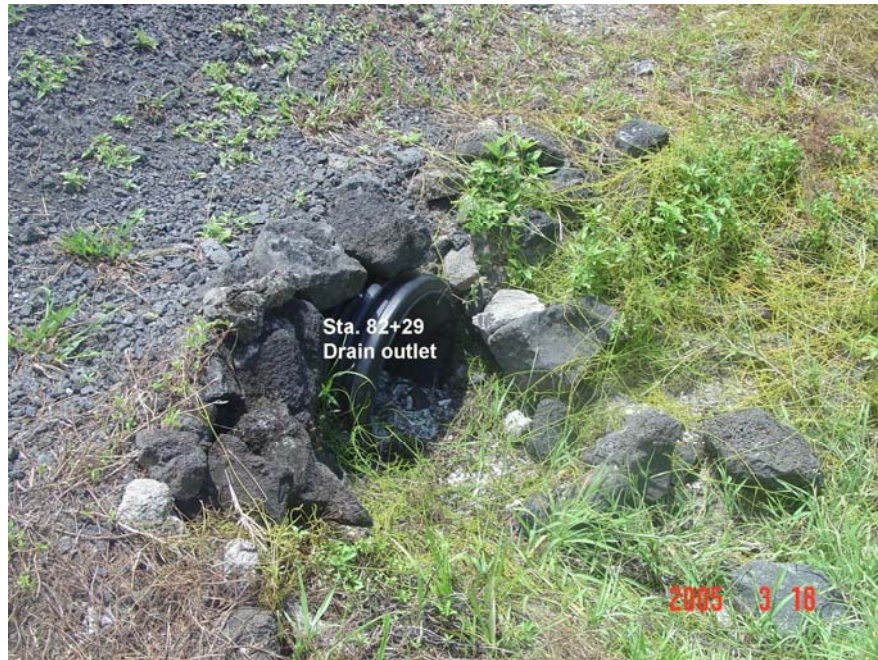
11. Sta. 82+29, drain outlet (same as above).

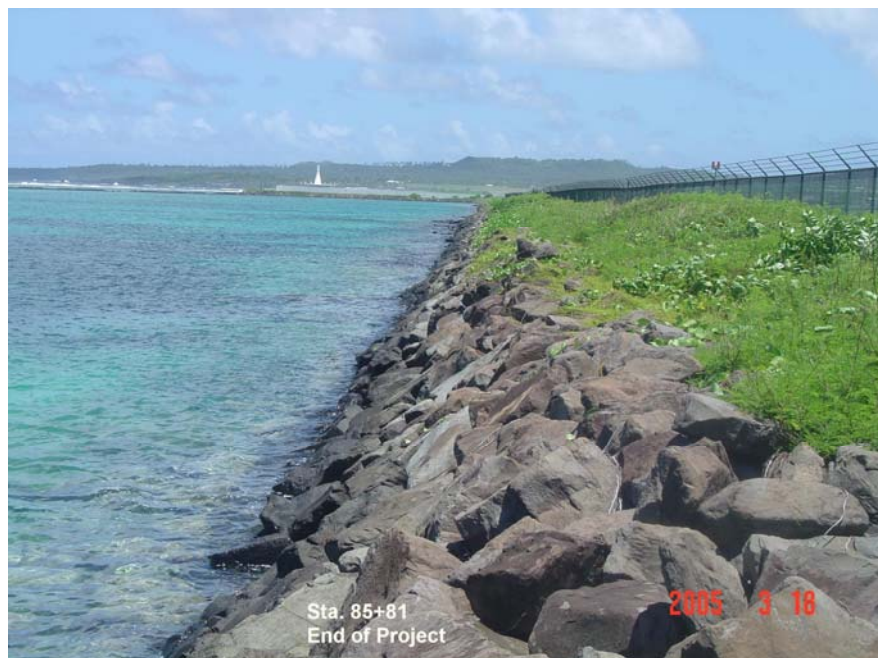
- mm. Sta. 85+81, end of project (no tieback constructed).
